## Biodetergents for Cooling Water

*By Dave Christophersen, Vice President/Technical Manager*

# CROWN SOLUTIONS CUSTOMER NEWSLETTER

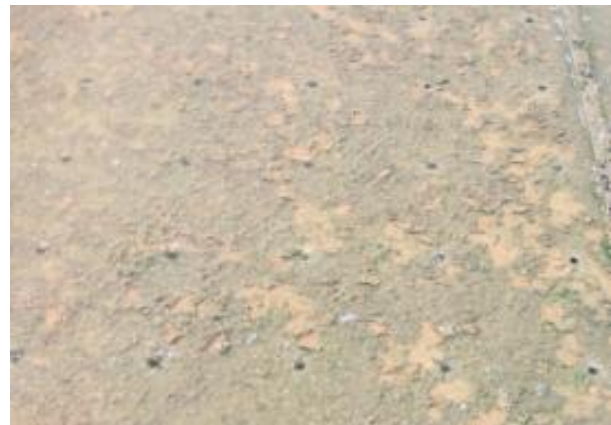
**Figure 1: Dirt and biofilm on a cooling tower distribution deck is shown sloughing off after an application of a biodetergent.**
